BEST PRACTICES FOR PROPERTY PROTECTION & LOSS PREVENTION

INSURANCE BOARD

PURPOSE STATEMENT

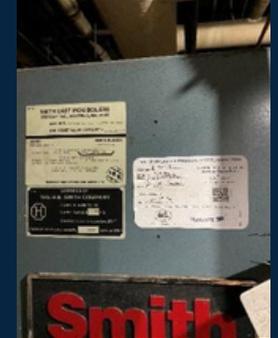
Boiler Past Inspection

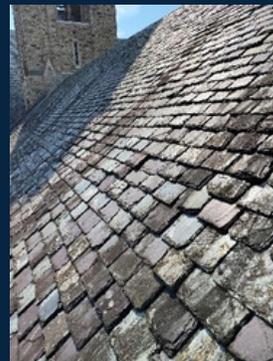
Maintained Roof

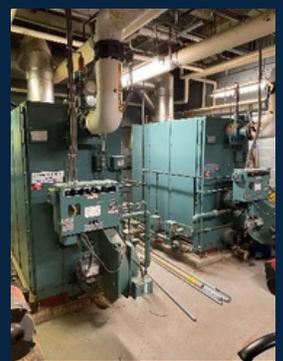
Clean Boiler Room

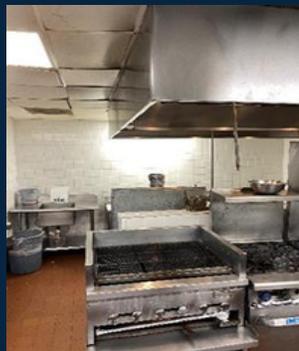
Equipment Not Under Exhaust Hood

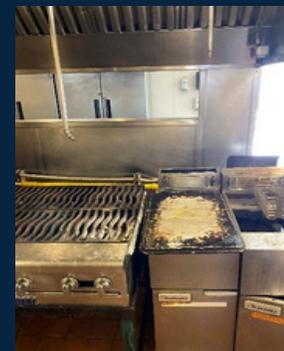
No Metal Baffle Installed

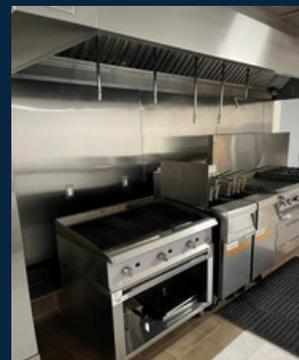
Metal Baffle Installed

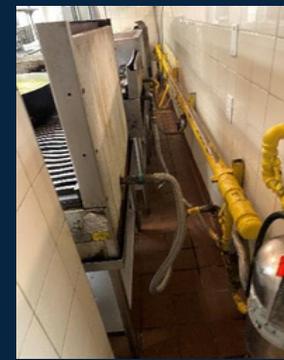
Metal Braided Hoses

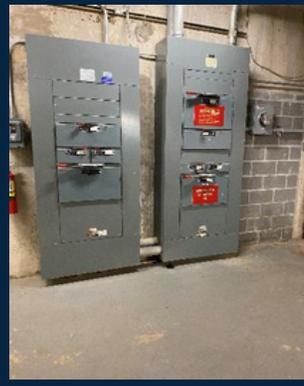
Adequate Clearance at Switchgear

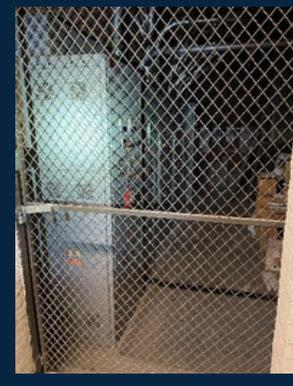
Secured Electrical Panel Area

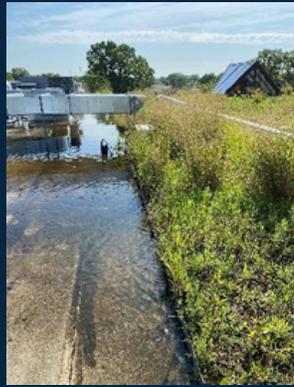
Blocked Roof Drains

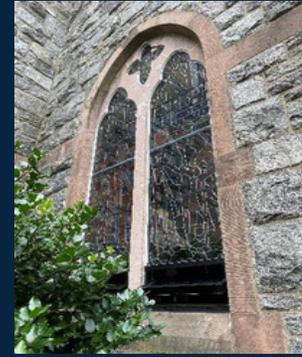
Non-Impact Windows/ Hurricane Shutters and Exposed to the Elements

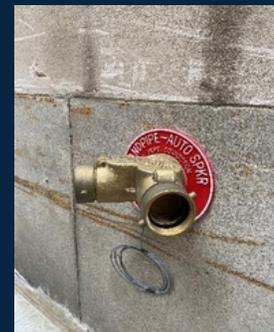
Missing Caps on Fire Department Connection

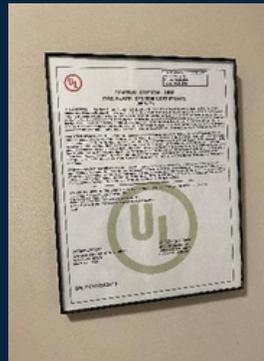
NFPA 72 Compliant Fire Alarm Monitoring

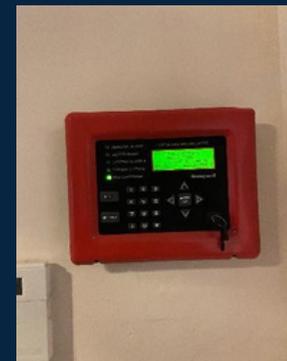
"All Systems Normal" Fire Alarm Panel

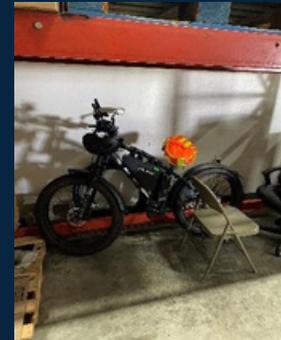
Improper E-Bike Charging and Storage

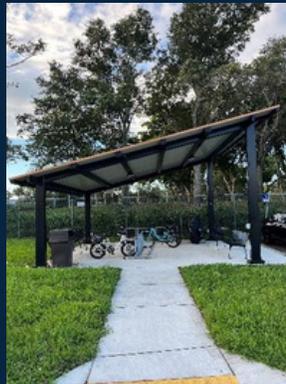
Adequate Exterior Storage/ Charging

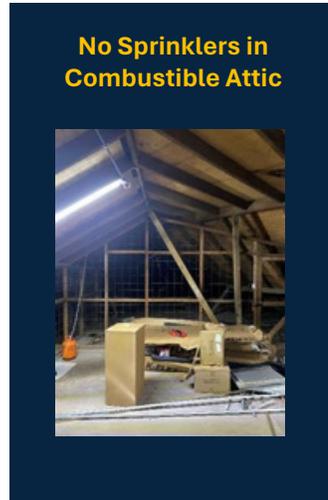
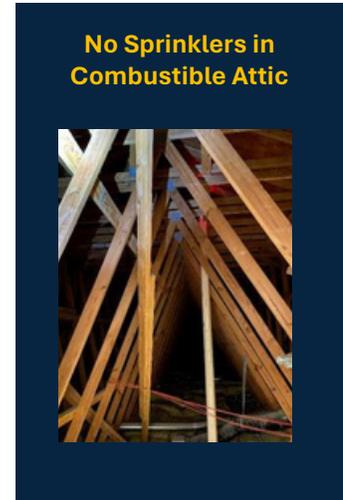
No Sprinklers in Combustible Attic

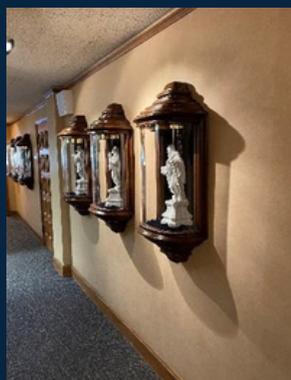
Adequately Protected Art/ Valuables

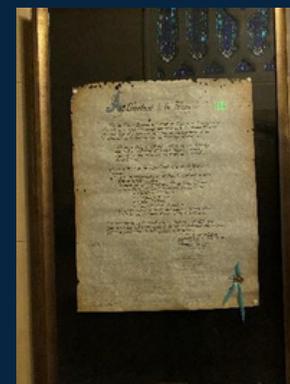
Adequately Protected Document
